Focused Site Inspection Prioritization Report

General Hydraulics

USEPA ID No. ILD 984 767 806

August 31, 1995

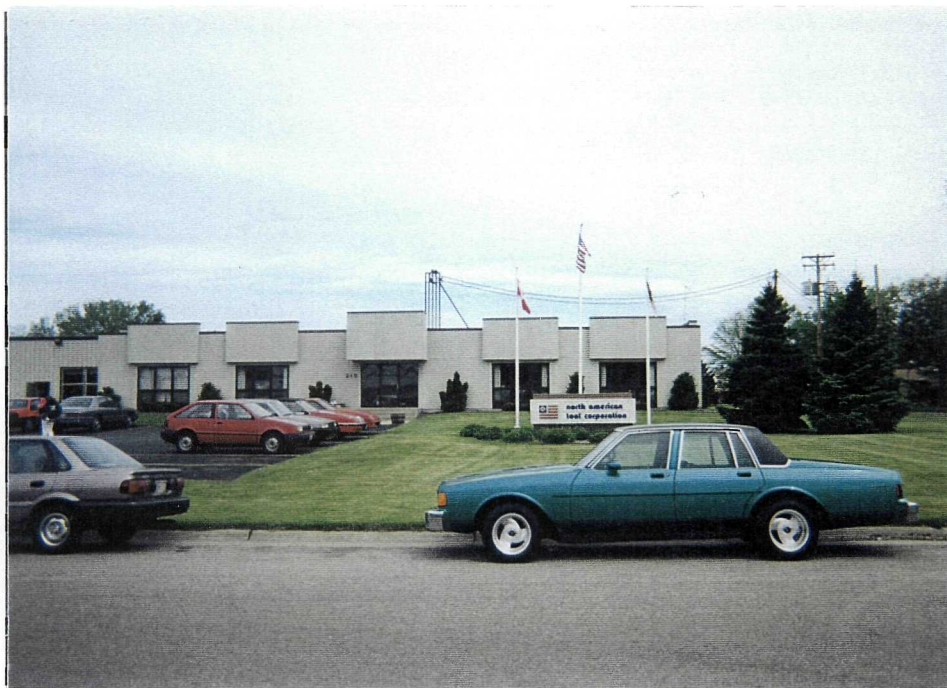
Date: May 17, 1995
Time: 1144
Photo Taken By: J. Noyes
Photo Number: 1
Site/ILD No.: General Hydraulics/ ILD984767806
Direction of Photo: Facing North
Description: From Elmwood Avenue, looking at the Corporation sign for NATCO.

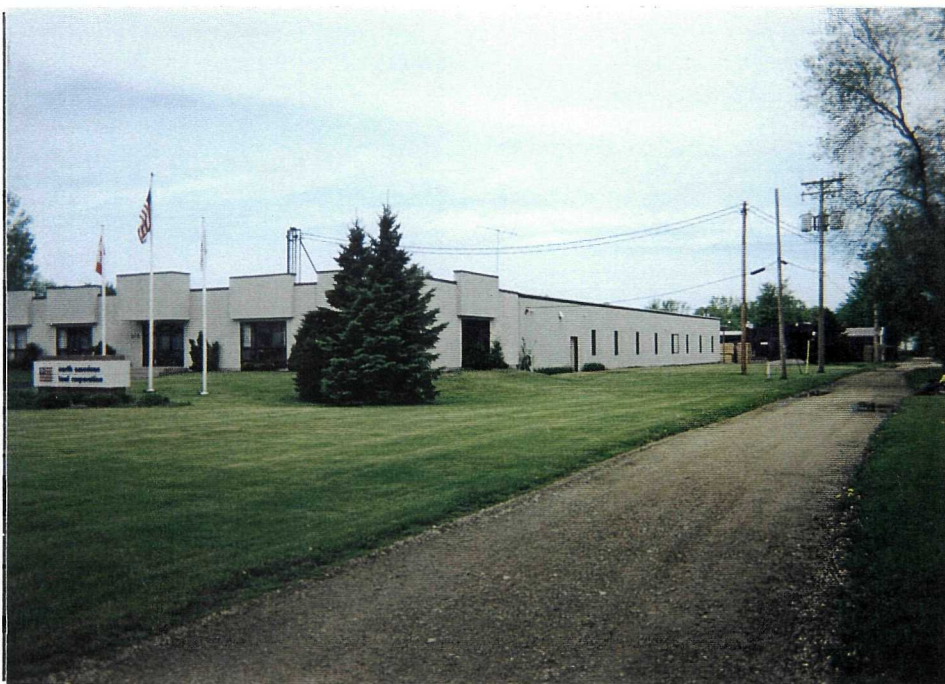
Date: May 17, 1995
Time: 1145
Photo Taken By: J. Noyes
Photo Number: 2
Site/ILD No.: General Hydraulics/ILD984767806
Direction of Photo: Facing Northwest
Description: From southeast corner of site, NATCO building and ACCRA building in background.

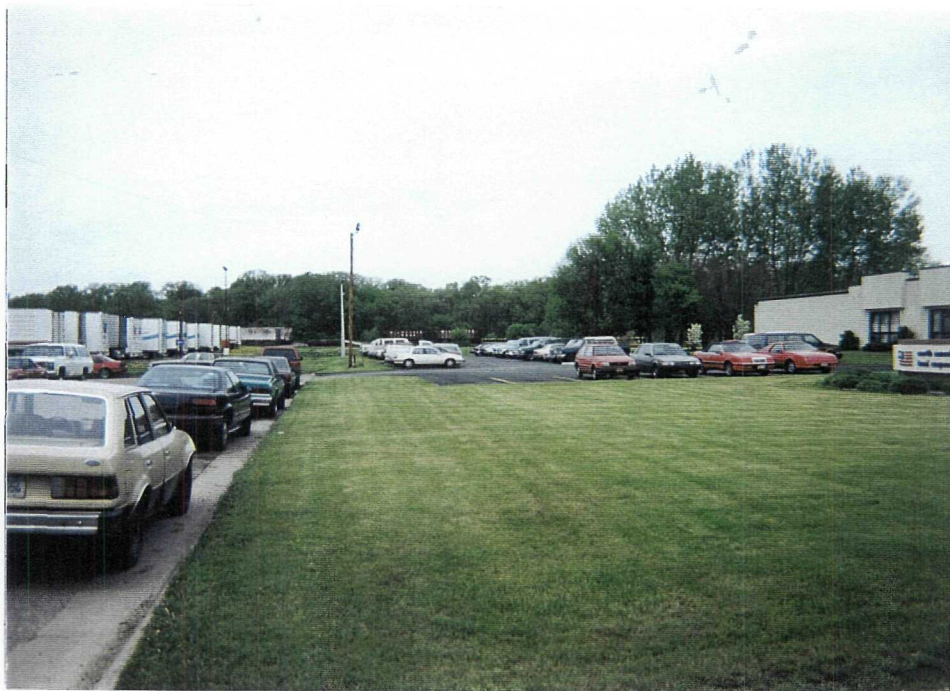
During the reconnaissance, surface drainage from the southern side of the employee parking lot appeared to flow west, where it ponded near the railroad tracks. Drainage from the border between NATCo and Trenwyth flows west, and ponds just west of Trenwyth's brick yard. Surface water ultimately flows into the Rock River. The stockpiled soil appears to be 15 to 20 feet wide, and 100 to 200 feet long. It is located along the railroad tracks near the western edge of the property.

Date: May 17, 1995
Time: 1145
Photo Taken By: J. Noyes
Photo Number: 3
Site/ILD No.: General Hydraulics/ ILD984767806
Direction of Photo: Facing West
Description: From southeast corner of site, parking lot and railroad in background.

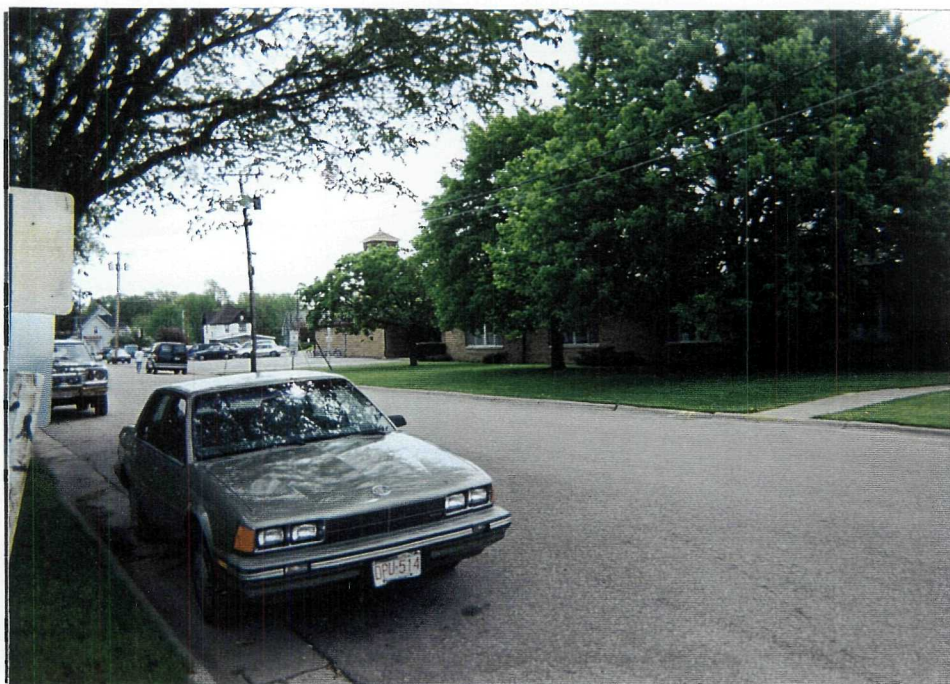
Date: May 17, 1995
Time: 1145
Photo Taken By: J. Noyes
Photo Number: 4
Site/ILD No.: General Hydraulic ILD984767806
Direction of Photo: Facing southeast
Description: From southeast corner of site in alley and Elmwood Avenue, picture of St. Peter School.

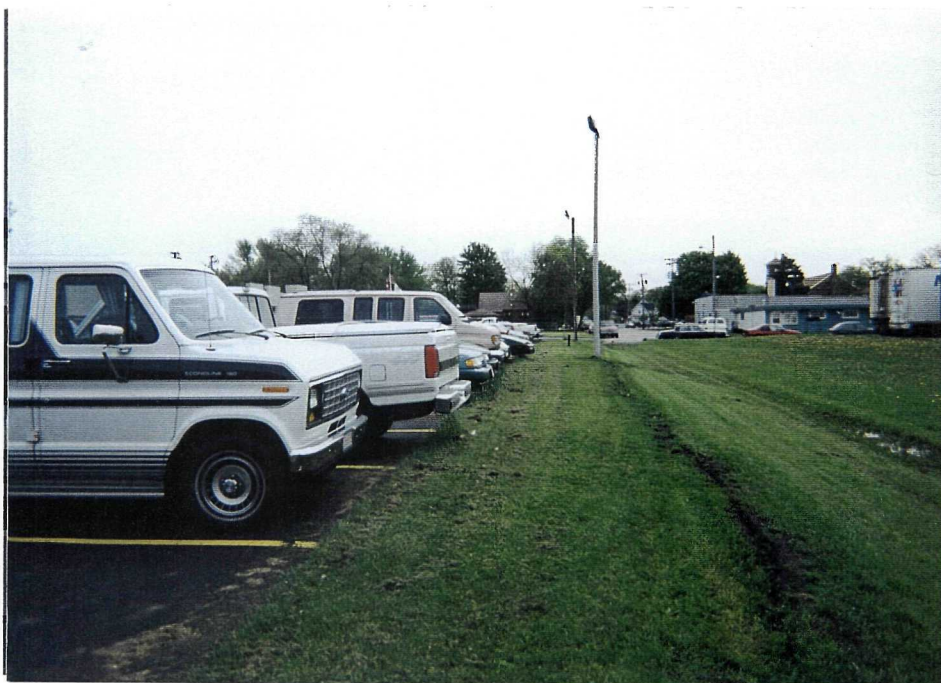
Date: May 17, 1995
Time: 1152
Photo Taken By: J. Noyes
Photo Number: 6
Site/ILD No.: General Hydraulics/ILD 984767806
Direction of Photo: Facing East
Description: From southwest corner of employee parking lot along south property line.

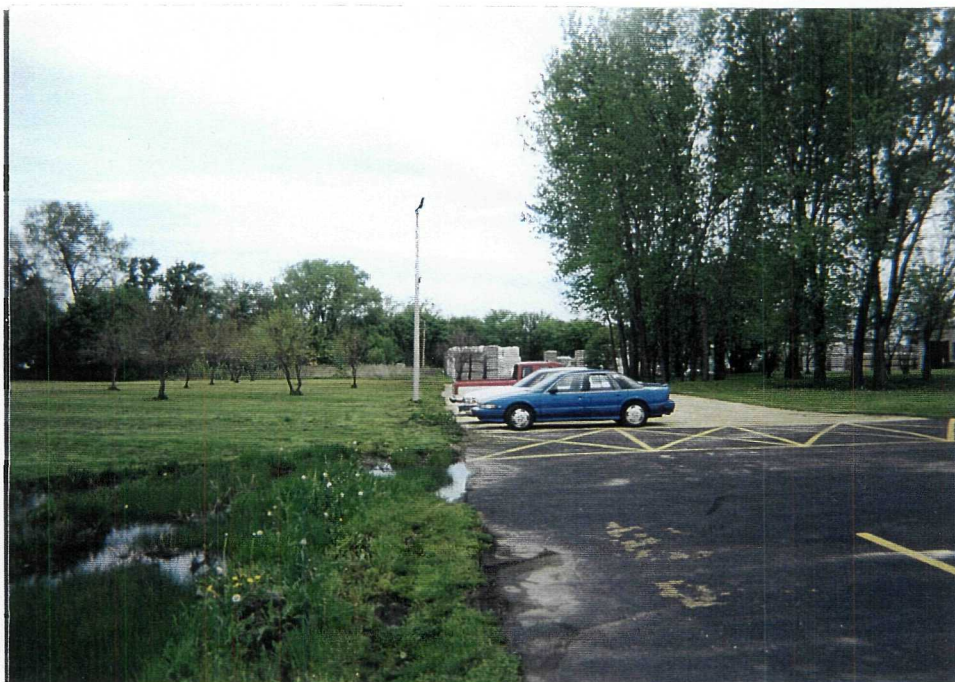
Date: May 17, 1995
Time: 1155
Photo Taken By: J. Noyes
Photo Number: 8
Site/ILD No.: General Hydraulics/ILD 984767806
Direction of Photo: Facing North
Description: Same location as in photo 7. Employee parking lot and Trenwyth cinder block yard in background.

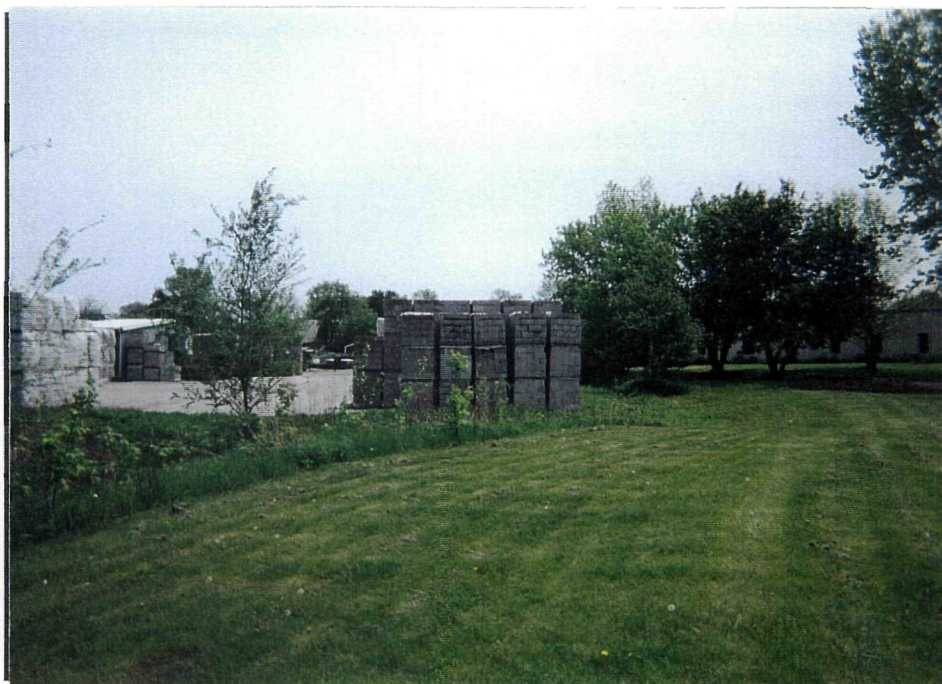
Date: May 17, 1995
Time: 1230
Photo Taken By: J. Noyes
Photo Number: 12
Site/ILD No.: General Hydraulics/ILD 984767806
Direction of Photo: Facing East
Description: Property line between NATCO and
Trenwyth from the west.

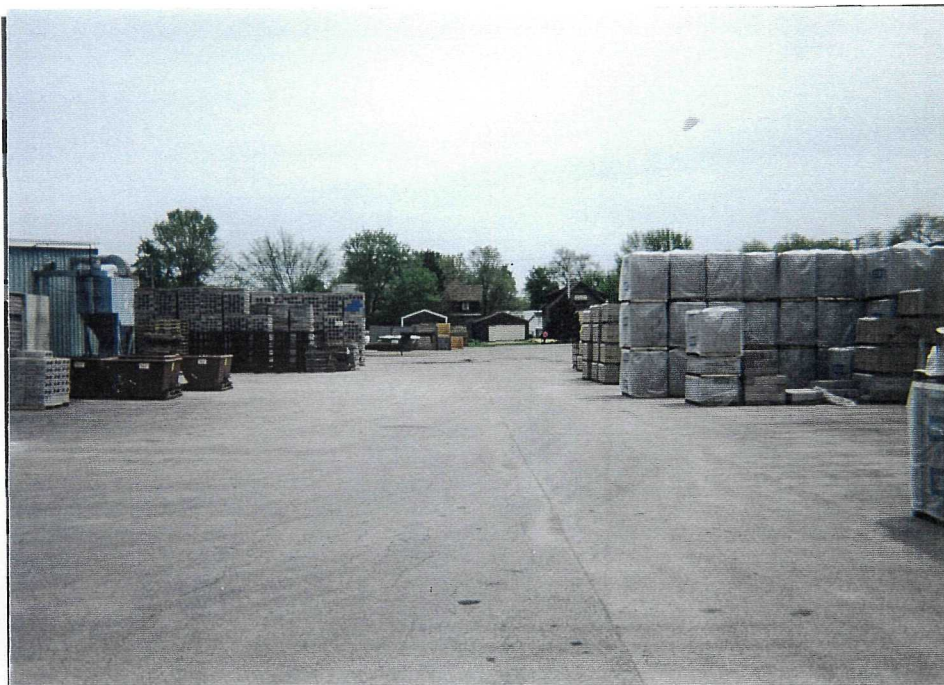
Date: May 17, 1995
Time: 1238
Photo Taken By: J. Noyes
Photo Number: 15
Site/ILD No.: General Hydraulics/ILD 984767806
Direction of Photo: East
Description: Taken from southwest corner of Trenwyth Brickyard. Picture of brickyard. Note that ACCRA is the brown building. Note residential home in the background.

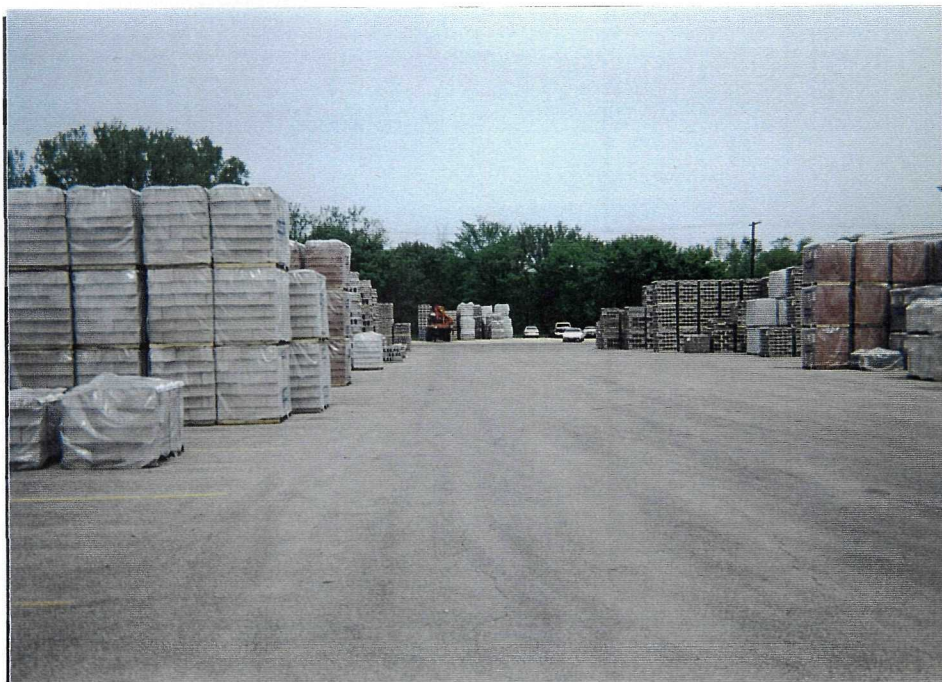
Date: May 17 1995
Time: 1239
Photo Taken By: J. Noyes
Photo Number: 16
Site/ILD No.: General Hydraulics/ILD 984767806
Direction of Photo: North
Description: Taken from the same location as Photo 15. Brickyard.

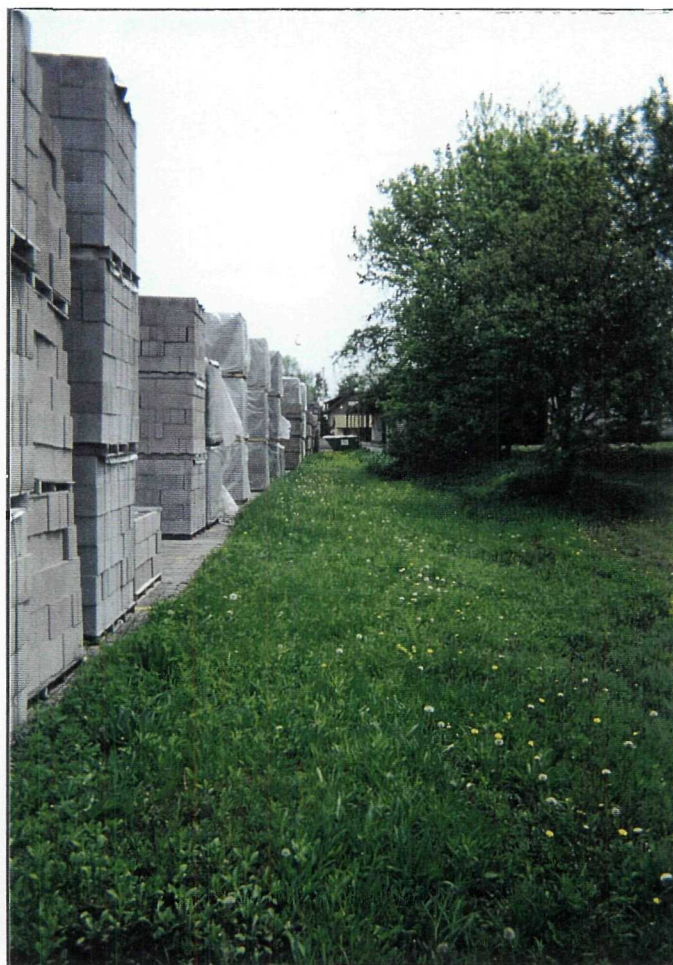
Date: May 17 1995
Time: 1246
Photo Taken By: J. Noyes
Photo Number: 17
Site/ILD No.: General Hydraulics/ILD 984767806
Direction of Photo: East
Description: Taken from west end of drainage ditch between NATCO and Trenwyth.

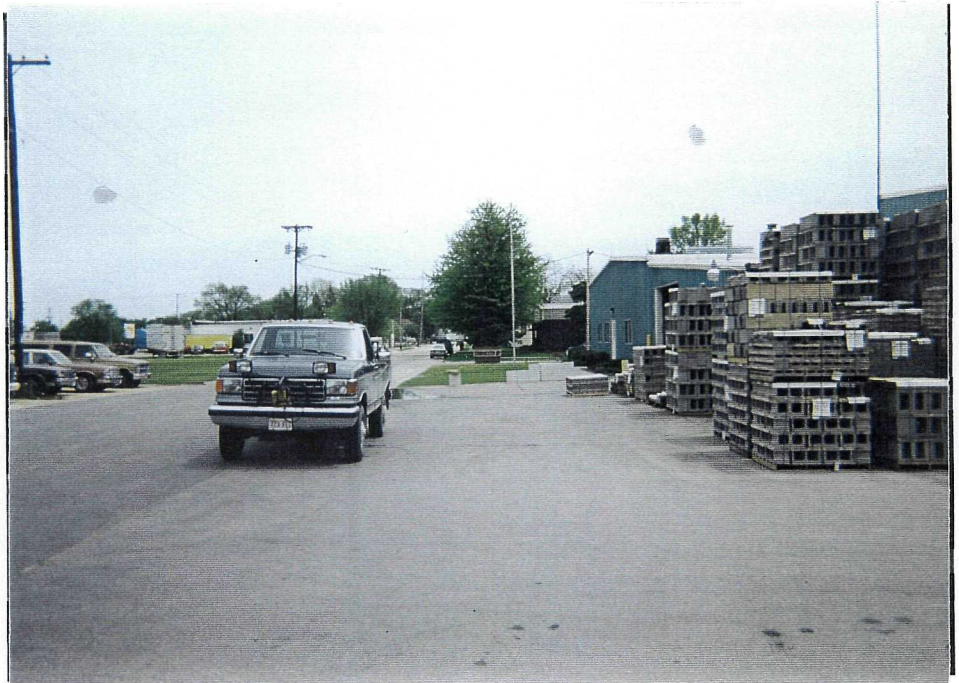
Date: May 17 1995
Time: 1248
Photo Taken By: J. Noyes
Photo Number: 18
Site/ILD No.: General Hydraulics/ILD 984767806
Direction of Photo: East
Description: Taken from the northwest corner of the site.

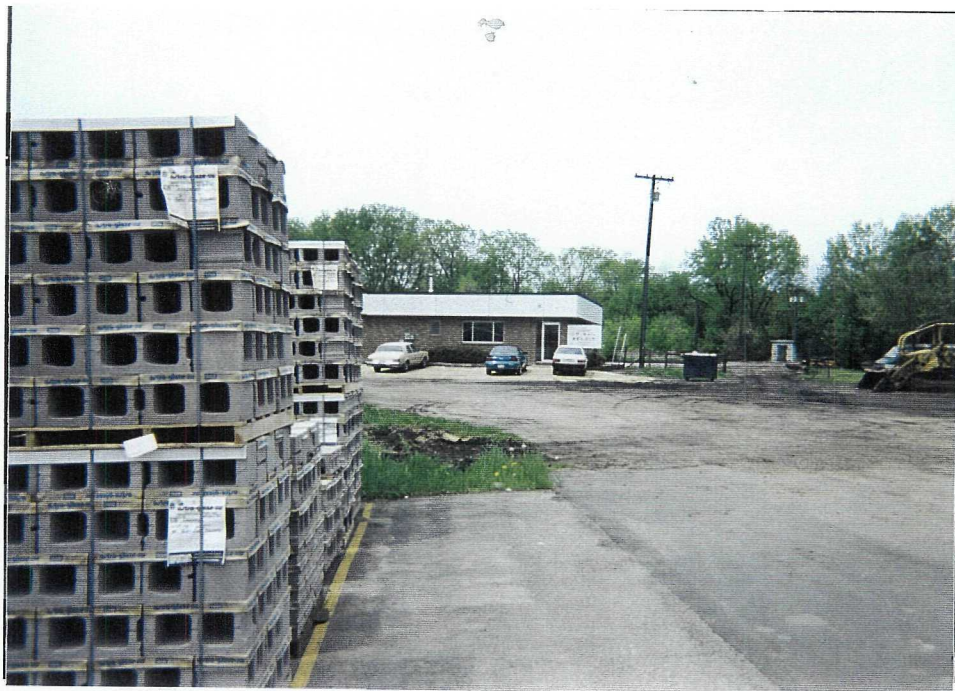
Date: May 17, 1995
Time: 1248
Photo Taken By: J. Noyes
Photo Number: 19
Site/ILD No.: General Hydraulics/ILD 984767806
Direction of Photo: West
Description: Taken from the same location as Photo 18. CP Railroad of Beloit.

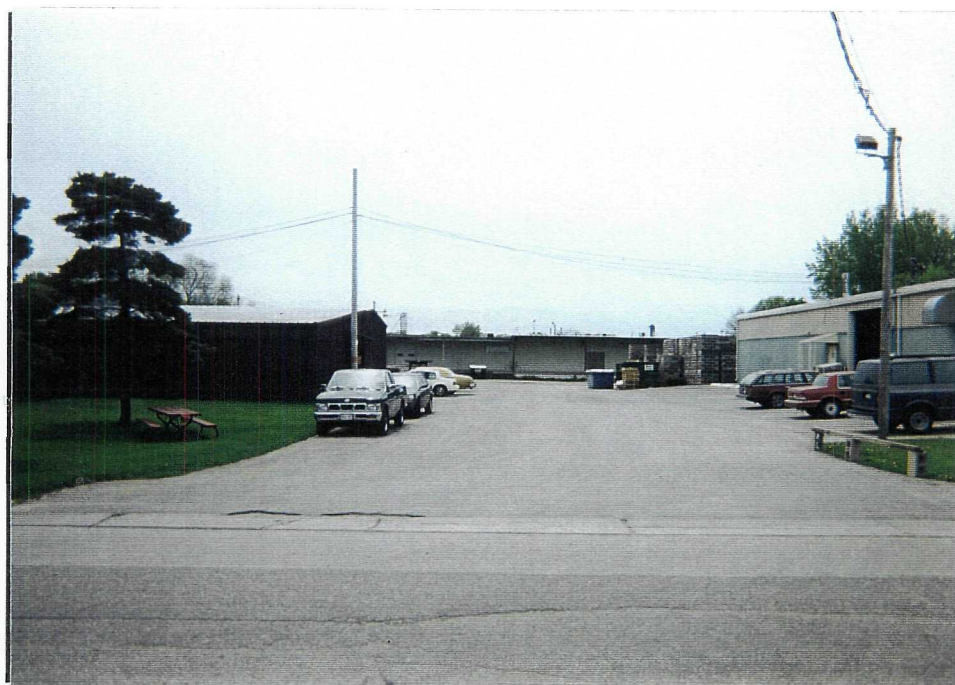
Date: May 17, 1995
Time: 1252
Photo Taken By: J. Noyes
Photo Number: 20
Site/ILD No.: General Hydraulics/ILD 984767806
Direction of Photo: South
Description: From north central area of the site between Trenwyth and ACCRA, NATCO in background.

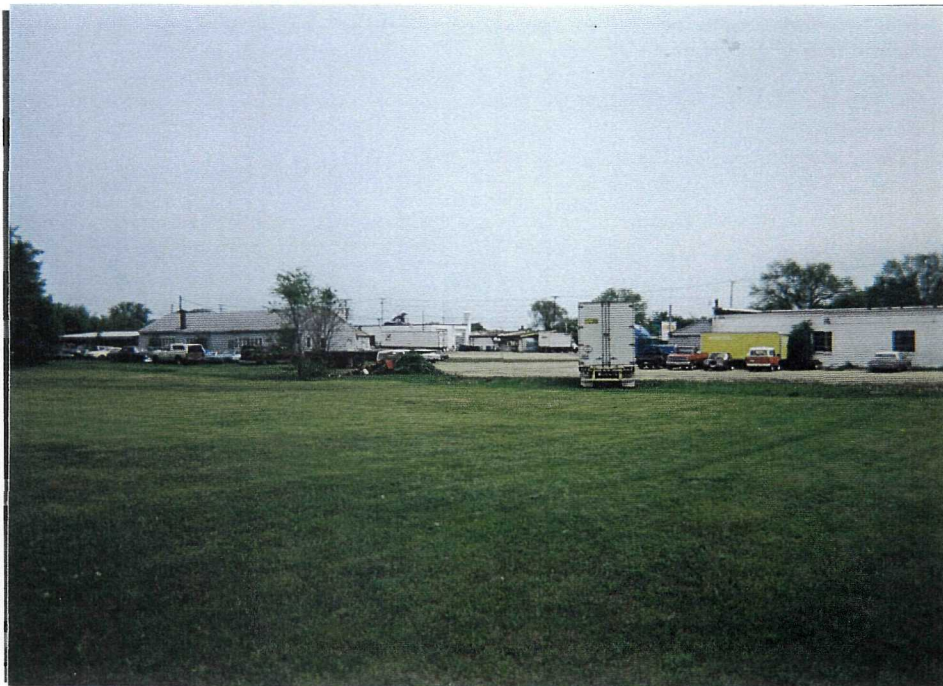
Date: May 17, 1995
Time: 1254
Photo Taken By: J. Noyes
Photo Number: 21
Site/ILD No.: General Hydraulics/ILD 984767806
Direction of Photo: Northeast
Description: Taken from from the same location as Photo 20. Neighboring car paint shop.

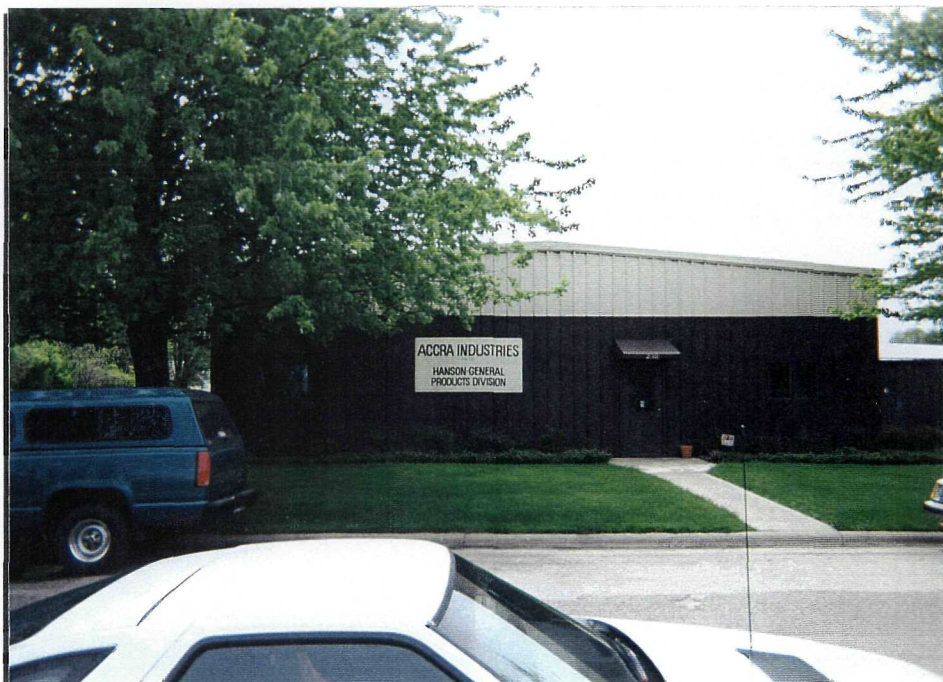
Date: May 17, 1995
Time: 1255
Photo Taken By: J. Noyes
Photo Number: 22
Site/ILD No.: General Hydraulics/ILD 984767806
Direction of Photo: South
Description: From Charles Street. ACCRA Industries Building and sign.

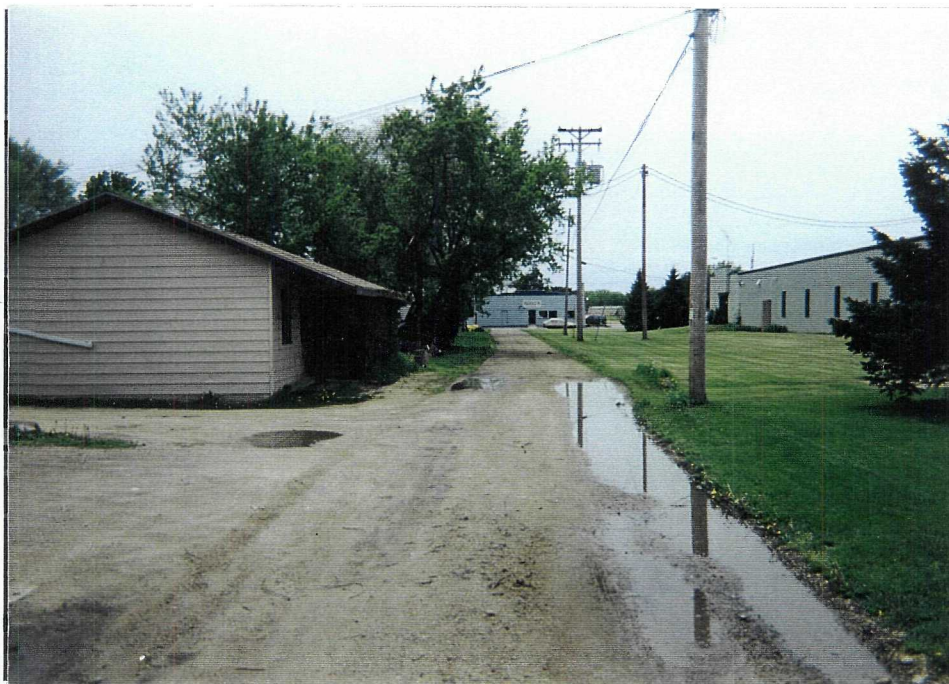
There are a number of private homes next to the site along Hayes Street that have groundwater wells in the surficial aquifer.

Date: May 17, 1995
Time: 1305
Photo Taken By: J. Noyes
Photo Number: 24
Site/ILD No.: General Hydraulics/ILD 984767806
Direction of Photo: South
Description: Looking down the alley between the
site and the residential homes of Hayes street.
